# Rehabilitation T E C H N O L O G Y

## Quick Reaction Turns Major Problem Into Routine Repair

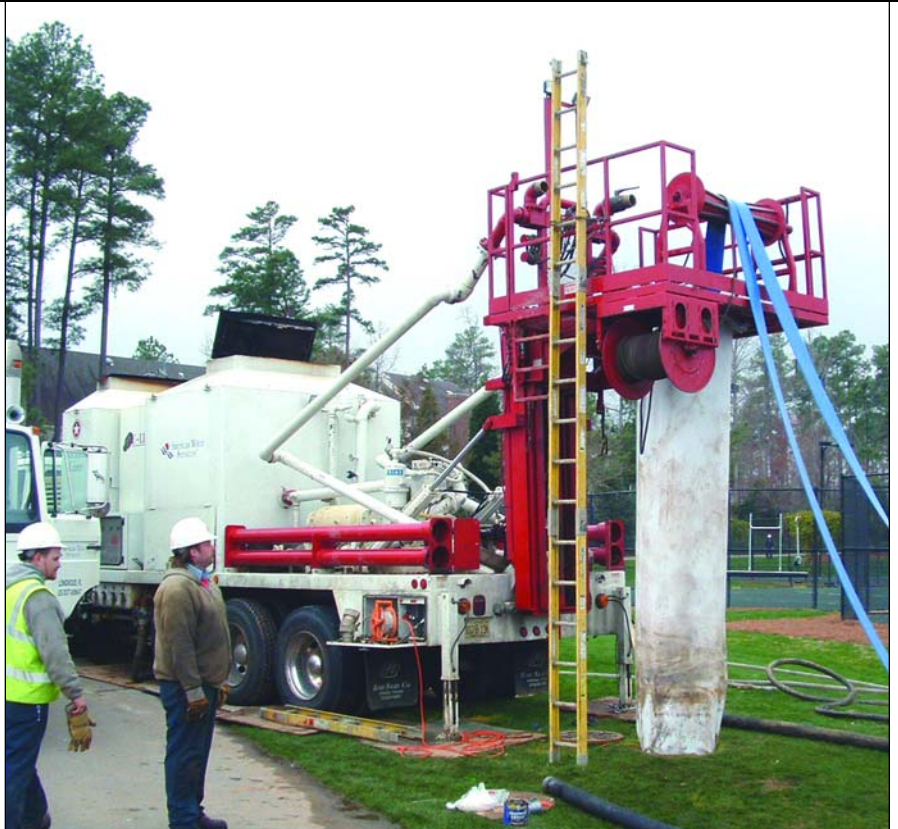
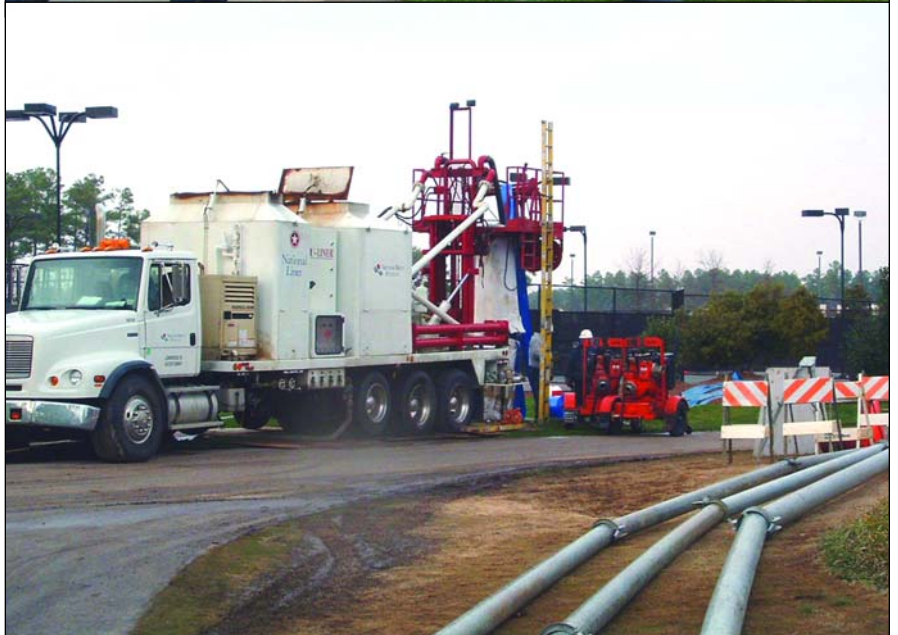
“This was a completely trenchless job,” said Krch. “We were able to invert the liner through an existing manhole cover without disassembling the manhole at all. With one shot of liner, we were able to rehabilitate more than 700 feet.”
