At 75 Feet, Repair Is One Of Deepest CIPP Jobs Ever Completed

by Joe Hastreiter, Contributing Editor

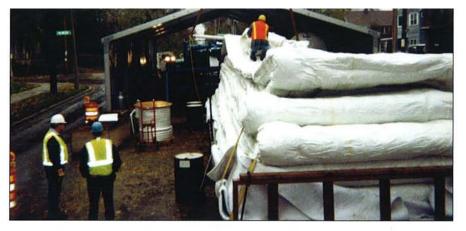
Above: Layers of felt are being examined as the crew prepares to inject the thermal-sensitive resin and catalyst system. Below: The resin-injected liner is lowered 75-feet to the sewer.

At ground level, the flattened felt liner was carefully unfolded as it was moved from the truck and fed onto a sloped table. Next, resin and a catalyst system were injected. Later, down in the sewer, hot water would be used to activate these chemicals and cause the liner to harden.

As a final preparation step, the liner was moved through pinch rollers that squeezed it to a specified thickness and caused the resin to completely saturate the liner fabric.
