FOCUS: SEWER

DRIVING DOWN I/I

CIPP lining and grouting of lateral connections proves to be a sound formula for tightening sewers in Graettinger, Iowa

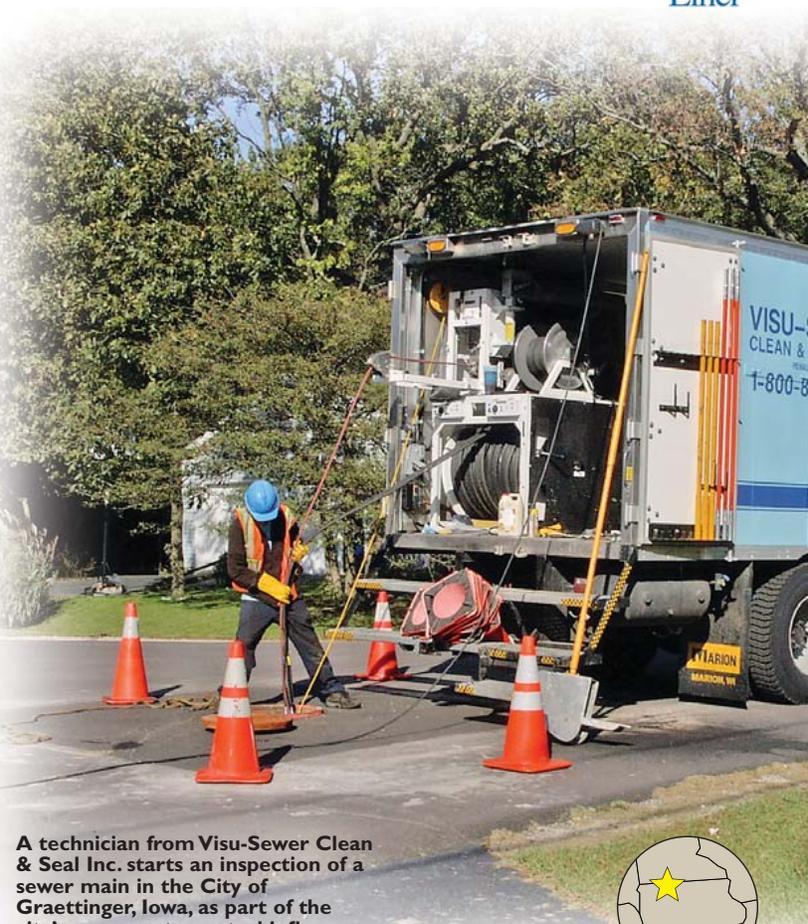
A technician from Visu-Sewer Clean & Seal Inc. starts an inspection of a sewer main in the City of Graettinger, Iowa, as part of the city's program to control inflow and infiltration.

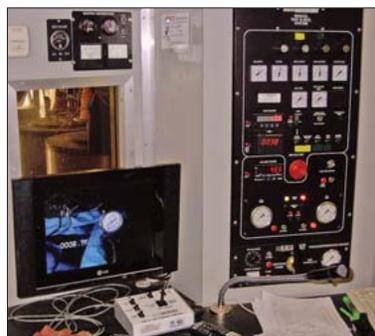
A fully outfitted camera van lets operators control the inspection and record findings.

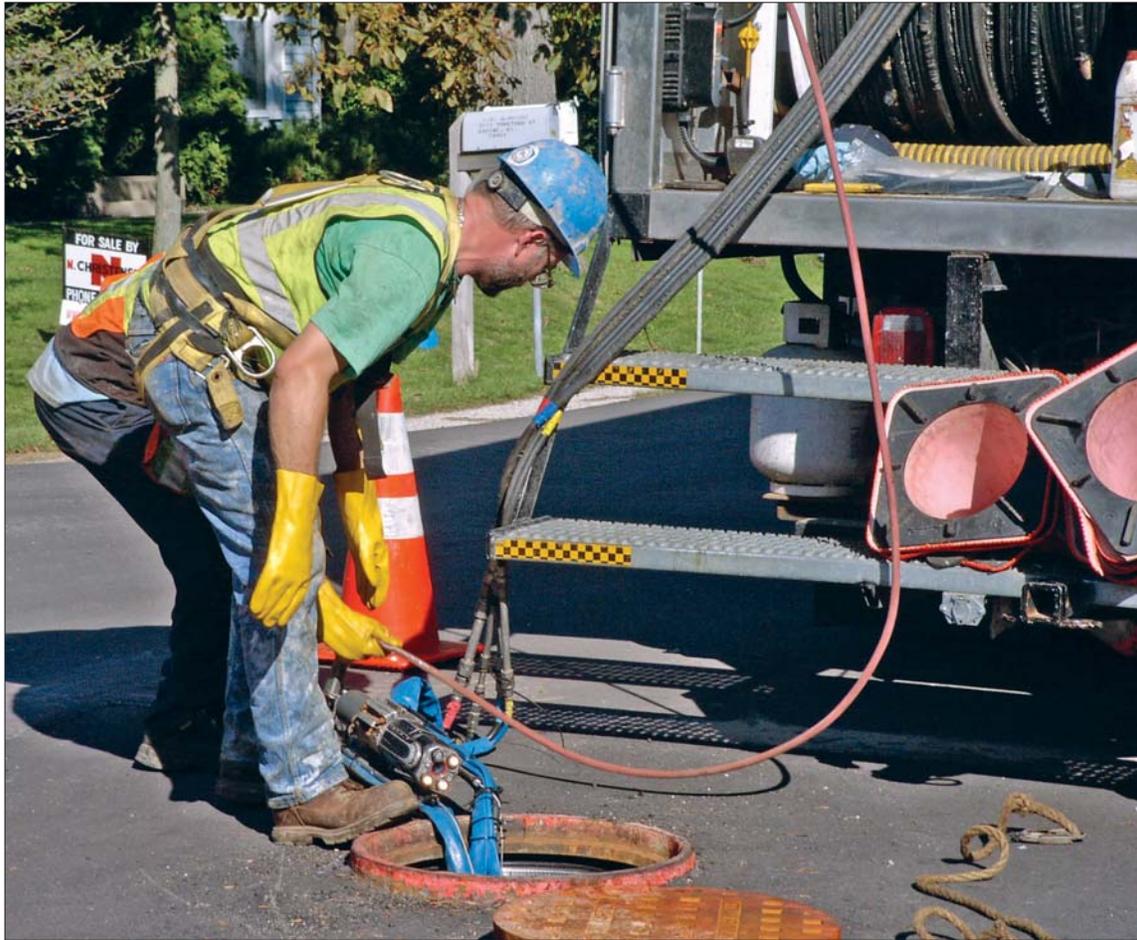
Camera inspection precedes CIPP lining in the city's I/I control program.

Visu-Sewer video-inspected the lines, cut roots, and cleaned the pipe with high-pressure waterjetters. The crew worked from manhole to manhole, inserting the liner through the pipe section using water inversion.

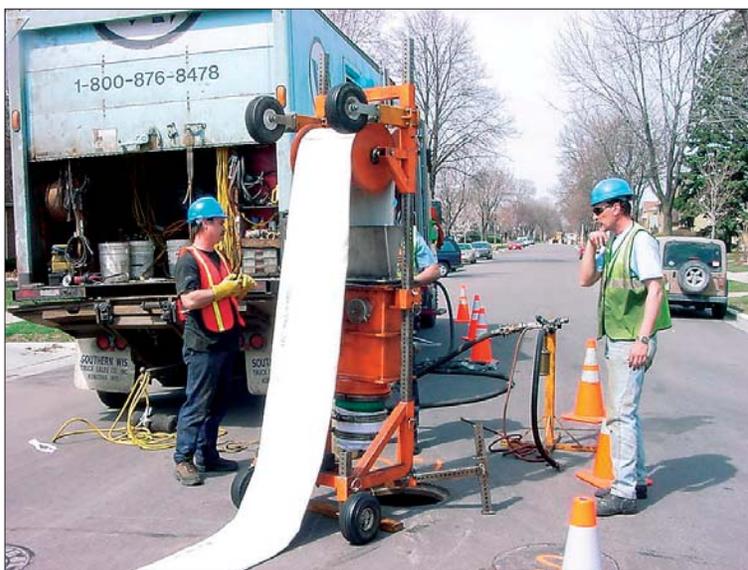
A crew prepares a CIPP lining from National Liner for a trenchless repair job on a main in Graettinger.

The custom-designed liner was made of 6 mm and 7.5 mm needle-woven polyester felt. The first step is a wet-out process in which the liner is laid on a processing table and a resin and catalyst system injected. The liner is then fed through rollers that compress the “dry bag” to a specified thickness and saturate it with resin.

To prepare the liner for the pipe, the first five to six feet are opened to a circular shape, and the leading edge is fastened to a circular frame. This results in a pocket into which water is pumped. The force of the water propels the liner down the pipe and turns it inside out.

Once deployed, the ends of the liner are secured, and the water is heated to 180 degrees F to activate curing. Temperature and water pressure are maintained throughout the process. Once cured, the liner is cooled and the ends trimmed and secured inside the manhole.

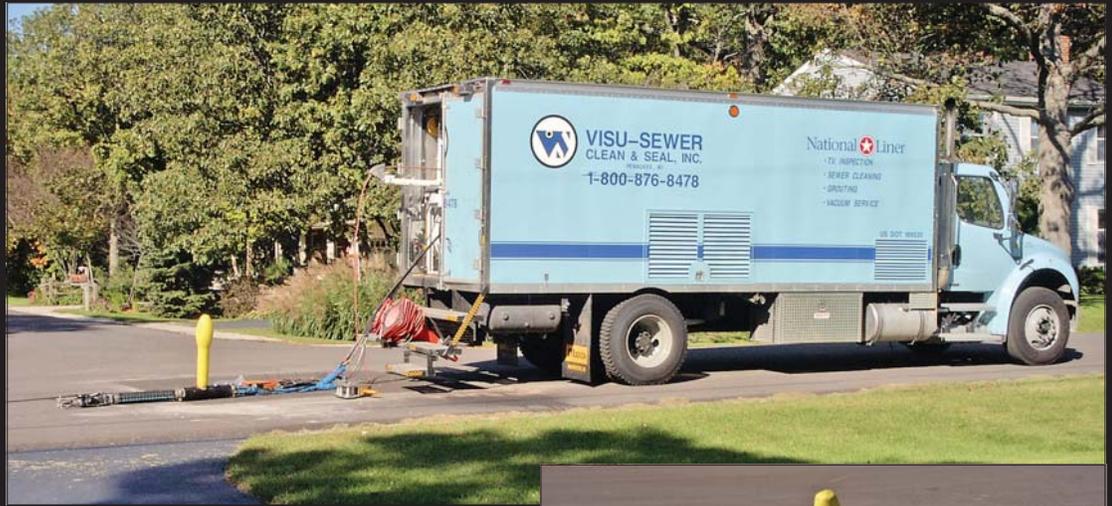
A lateral packer system from Logiball Inc. is deployed on a grouting project. Grouting and CIPP lining were the city's preferred methods of sealing lines against I/I.

In the last step to prevent infiltration, connections to the main line were grouted in place. During this process, three bladders within the lateral packer from Logiball Inc. were used to isolate the connection: two in the mainline (one on each side of the connection) and a third in the lateral. The bladders were inflated and the joint pressurized to force gel grout out and around the
